## Disassembly and reassembly of a Continental CL10 & CL10H Progressing Cavity Pump

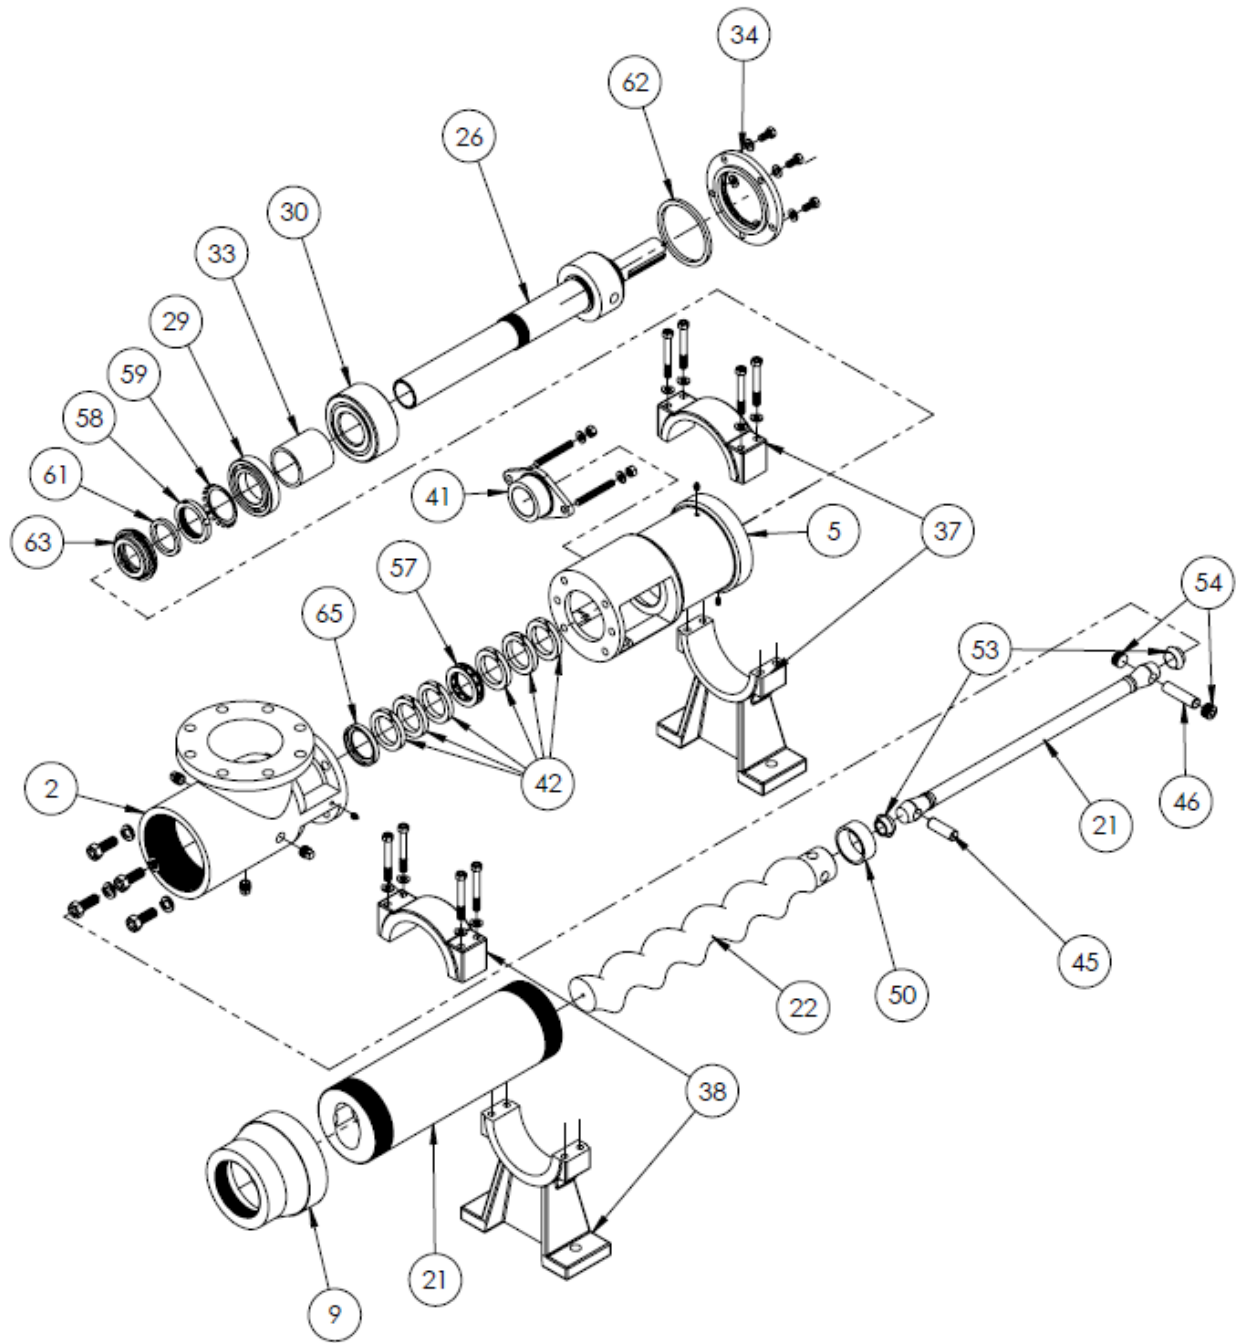
1. Remove the reducer, #9 from the discharge end of the pump. Remove clamp bolts from stator housing support, #38, and pull off the top half of stator support from stator, #21. Place temporary support under suction housing, #2, using a block of wood. Remove the bottom half of the stator support, #38.

2. By using pipe wrench remove stator, #21 from main body casting, #2. Pull stator, #21 off rotor, #22.
3. Remove two drive pin retainer screws, #54, with allen wrench and driveshaft pin, #46, by pushing pin through drive pin screw holes.

4. Pull rotor, #22, out of driveshaft, #26.
5. To dis-assemble rotor and connecting rod, press rotor band, #50, off rotor head, push rotor pin, #45, out of rotor head, then pull connecting rod, #25, out of rotor head. To re-assemble rotor and connecting rod, use new connecting rod washers, #53.

6. Remove five cap screws from bearing cover plate, #34.
7. We recommend using a press to remove driveshaft, #26 and bearing assembly from bearing housing, #5. If press is not available insert a rod into driveshaft, #26, through main body castings, #2, and drive ball bearings and shaft assembly out of main body casting, #2.

8. To dis-assemble driveshaft, #26 and ball bearings, remove lock nut, #58, and washer, #59, then press bearings, #29 and #30, and bearing spacer, #33, off driveshaft, #26. When reinstalling bearings, #29 and #30, they should be packed with good anti-friction bearing grease.
